FEATURE ARTICLE - RAIL GRINDING

Specialized Rail Profile Grinding on MBTA

by Bob Tuzik • April 10, 2005

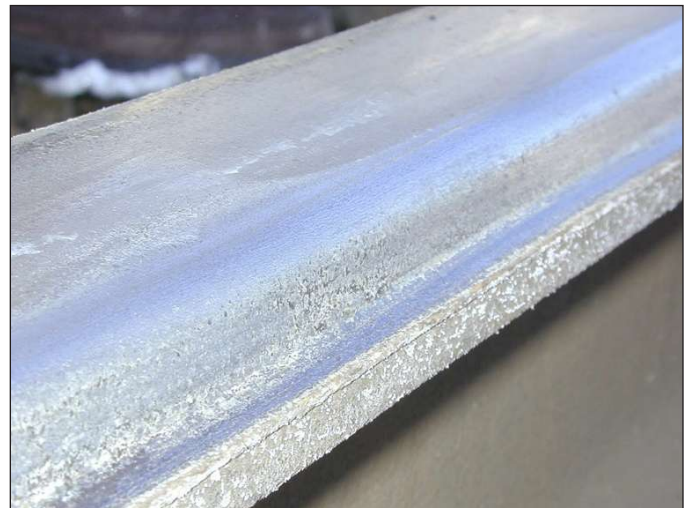
In addition to the issues relating to flange angle, wheels on the MBTA have a shallow, 3/4-inch flange length. As the wheel flanges contacted the gauge face of the rail, they wore the upper portion of the rail and created a shelf beneath the tip of the flange (see Figure 1). The shelf became an area of concern. Depending on the diameter of the wheel relative to the length of the flange, flange bearing could occur.

Figure 1. MBTA's shallow, 3/4-inch flange carved a shelf into the rail beneath the tip of the flange.

Rail replacement was considered but was rejected as too costly. MBTA concluded that it had to find a cost-effective way to grind away the shelf that had been carved into the rail, then grind a 10- to 20-degree angle on the gauge-face that would be compatible with the 75-degree IWP. The problem was, grinding at those angles had never been done in North America.

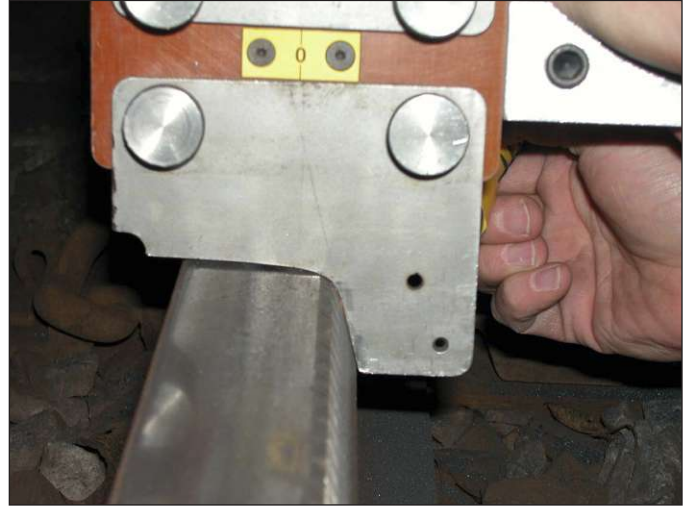
"Our goal was to grind as near vertical as possible on the gauge face of the rail," says ARM President Gordon Bachinsky. "We could see that a 10- to 15-degree gauge-face angle would mate well with a 75-degree flange angle on the wheel." (Figure 2)

Figure 2. Rail was ground as near vertical as possible to remove the gauge-face shelf and provide an angle compatible with the wheel flange.

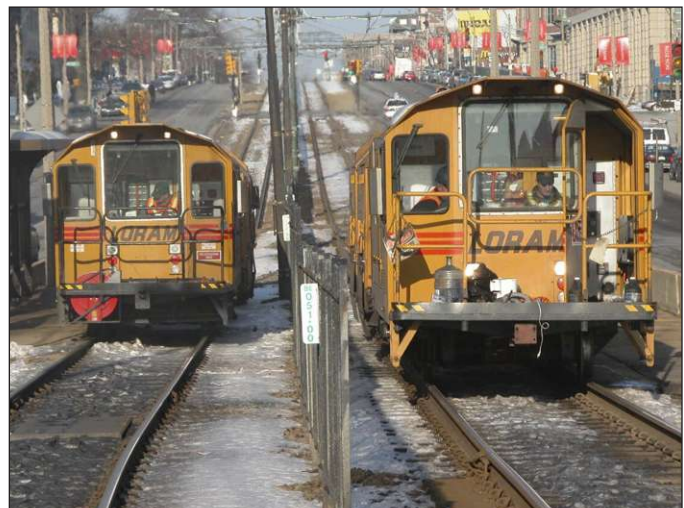
Figure 3. ARM used a pair of Loram L-Series grinders to meet MBTA's needs.

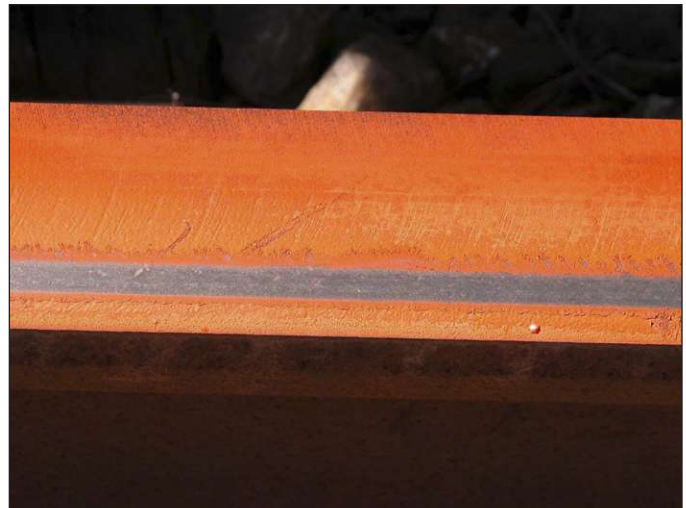
ARM/RESCO designed a series of new profiles with 3/8-inch running bands to take better advantage of rolling radius difference and thereby improve steering (see Figure 4). Multiple contact points reduced point loadings and the potential for rolling contact fatigue; the profiles also spread the wear to help maintain the tread shape and surface of the wheel.

Figure 4. A range of narrow, 3/8-inch contact bands was used to vary wheel-tread contact on tangent track.
